MODU Performance in Hurricane Ivan

This article, written by Assistant Technology Editor Karen Bybee, contains highlights of paper OTC 18322, "MODU Performance in Hurricane Ivan," by B.P.M. Sharples, SPE, Offshore Risk & Technology Consulting Inc., and S. Buffington, U.S. Minerals Management Service, prepared for the 2006 Offshore Technology Conference, Houston, 1-4 May.

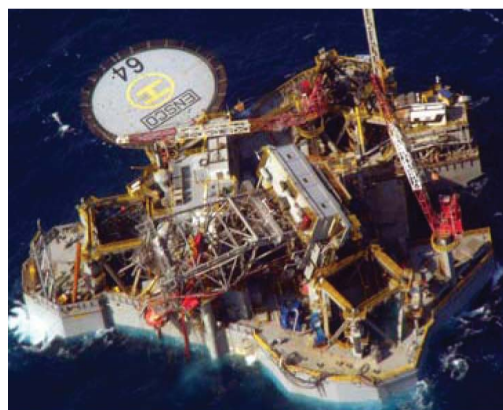
Fig. 1—Ensko 64 after Hurricane Ivan.

Ensco 64. The Ensco Intl. Inc. *Ensco 64* was a Letourneau 53 Class slot jackup built in 1973. It had been upgraded to increase the leg length to 477 ft, reinforce the legs, and increase the preload capacity to increase water-depth capability. It was at its deepest water depth at this location. *Ensco 64* was stationed 6 miles to the west of the central path of the eye. The air gap, 46 ft, would have allowed the jackup to weather most 100-year storms and was close to the 48.5 ft recommended by API RP 2A. On the basis of calculations made after the specific wind and wave data for Ivan were available, it is likely that the hull was inundated with waves. To have survived, the air gap would have needed to be closer to 58 ft.

The wind, waves, and current exceeded the design by a large margin. Ivan imposed forces on the rig almost double the design wave height. The legs sheared off below the hull. All three legs failed. One leg had a length of 100 ft, another a 65-ft length, while the third leg was completely gone. **Fig. 1** shows the *Ensco 64* after Ivan.
